# EVALUATION OF HARVEY TWO-PIECE LANDING MAT (AM2)

November 1966

Naval Air Engineering Center  
Philadelphia, Pennsylvania

U. S. Army Engineer Waterways Experiment Station  
CORPS OF ENGINEERS  
Vicksburg, Mississippi

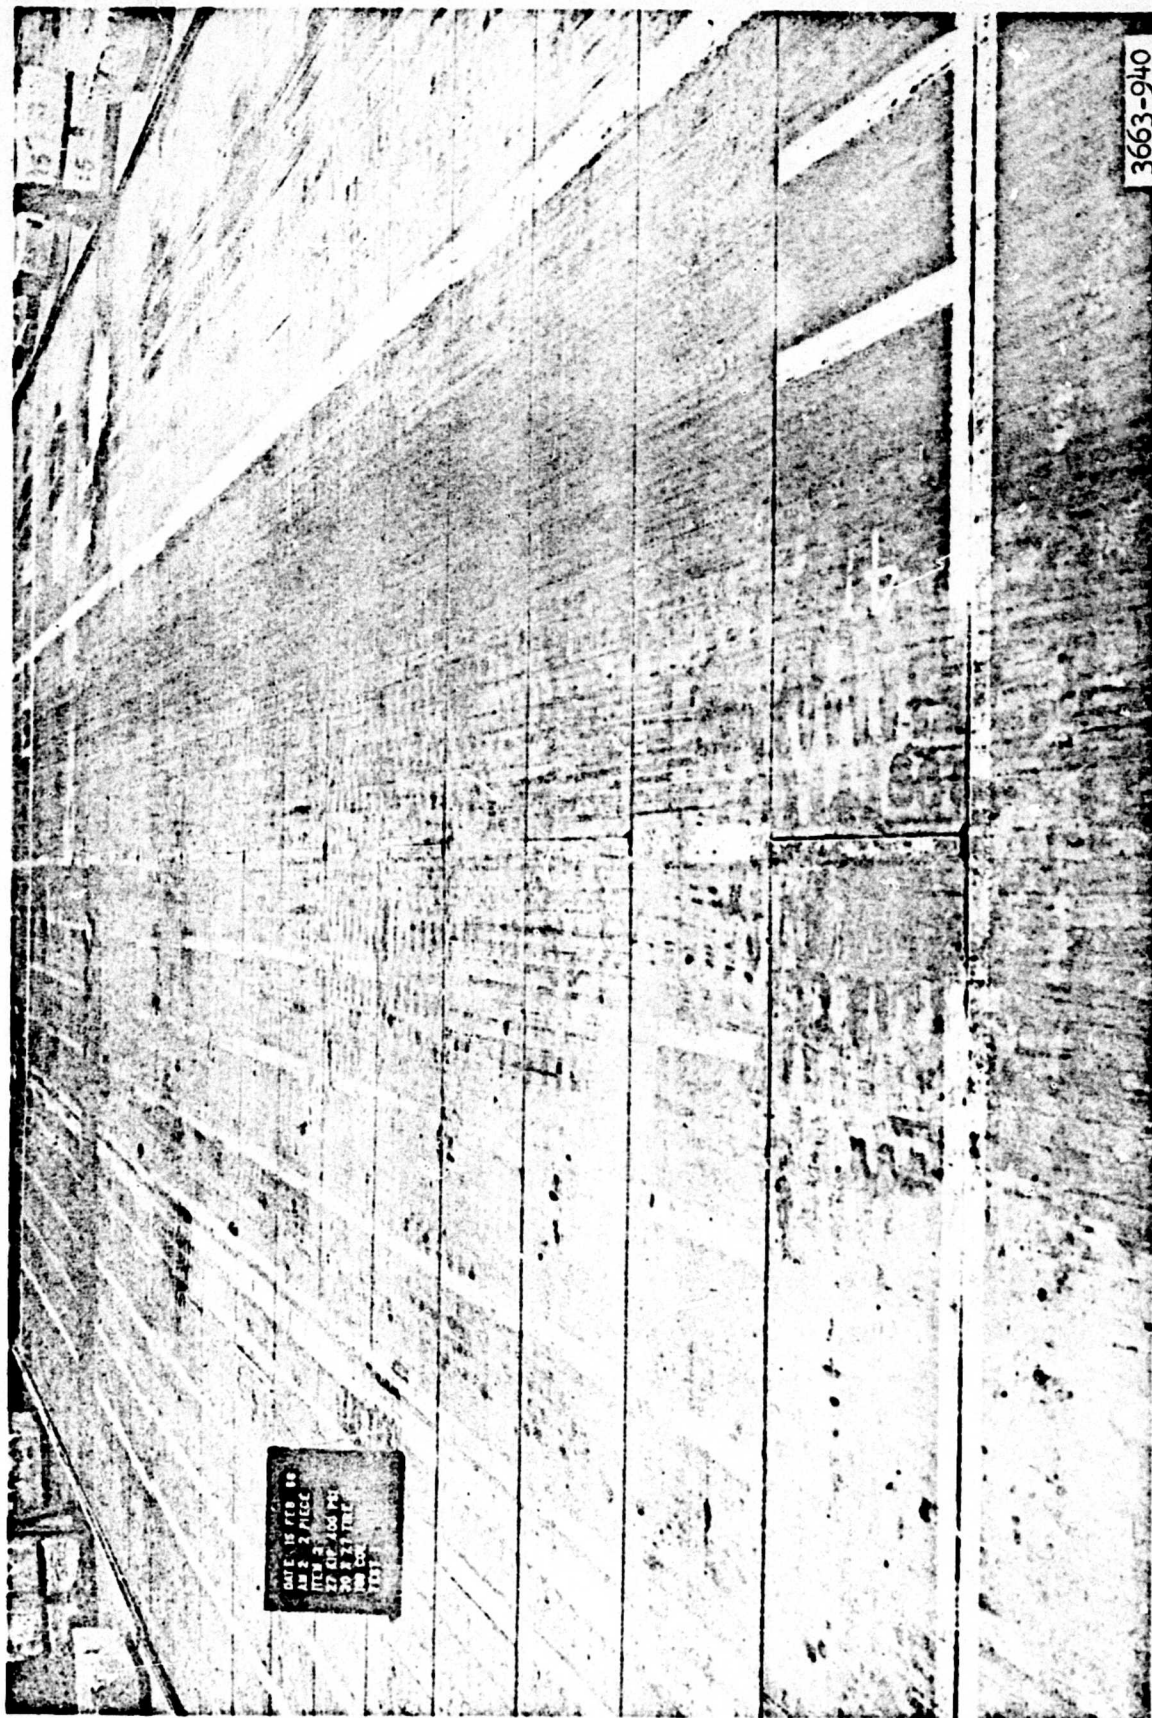
25. The mat in test items 3 and 4 was in good condition after 130 coverages except for one end connector joint failure in item 3. Traffic was continued for the full 188 coverages on these two items with no further failures developing. General views of items 3 and 4 after 188 coverages are shown in photographs 5 and 6, respectively.

Photograph 5. Lane 1, item 3, after 188 coverages

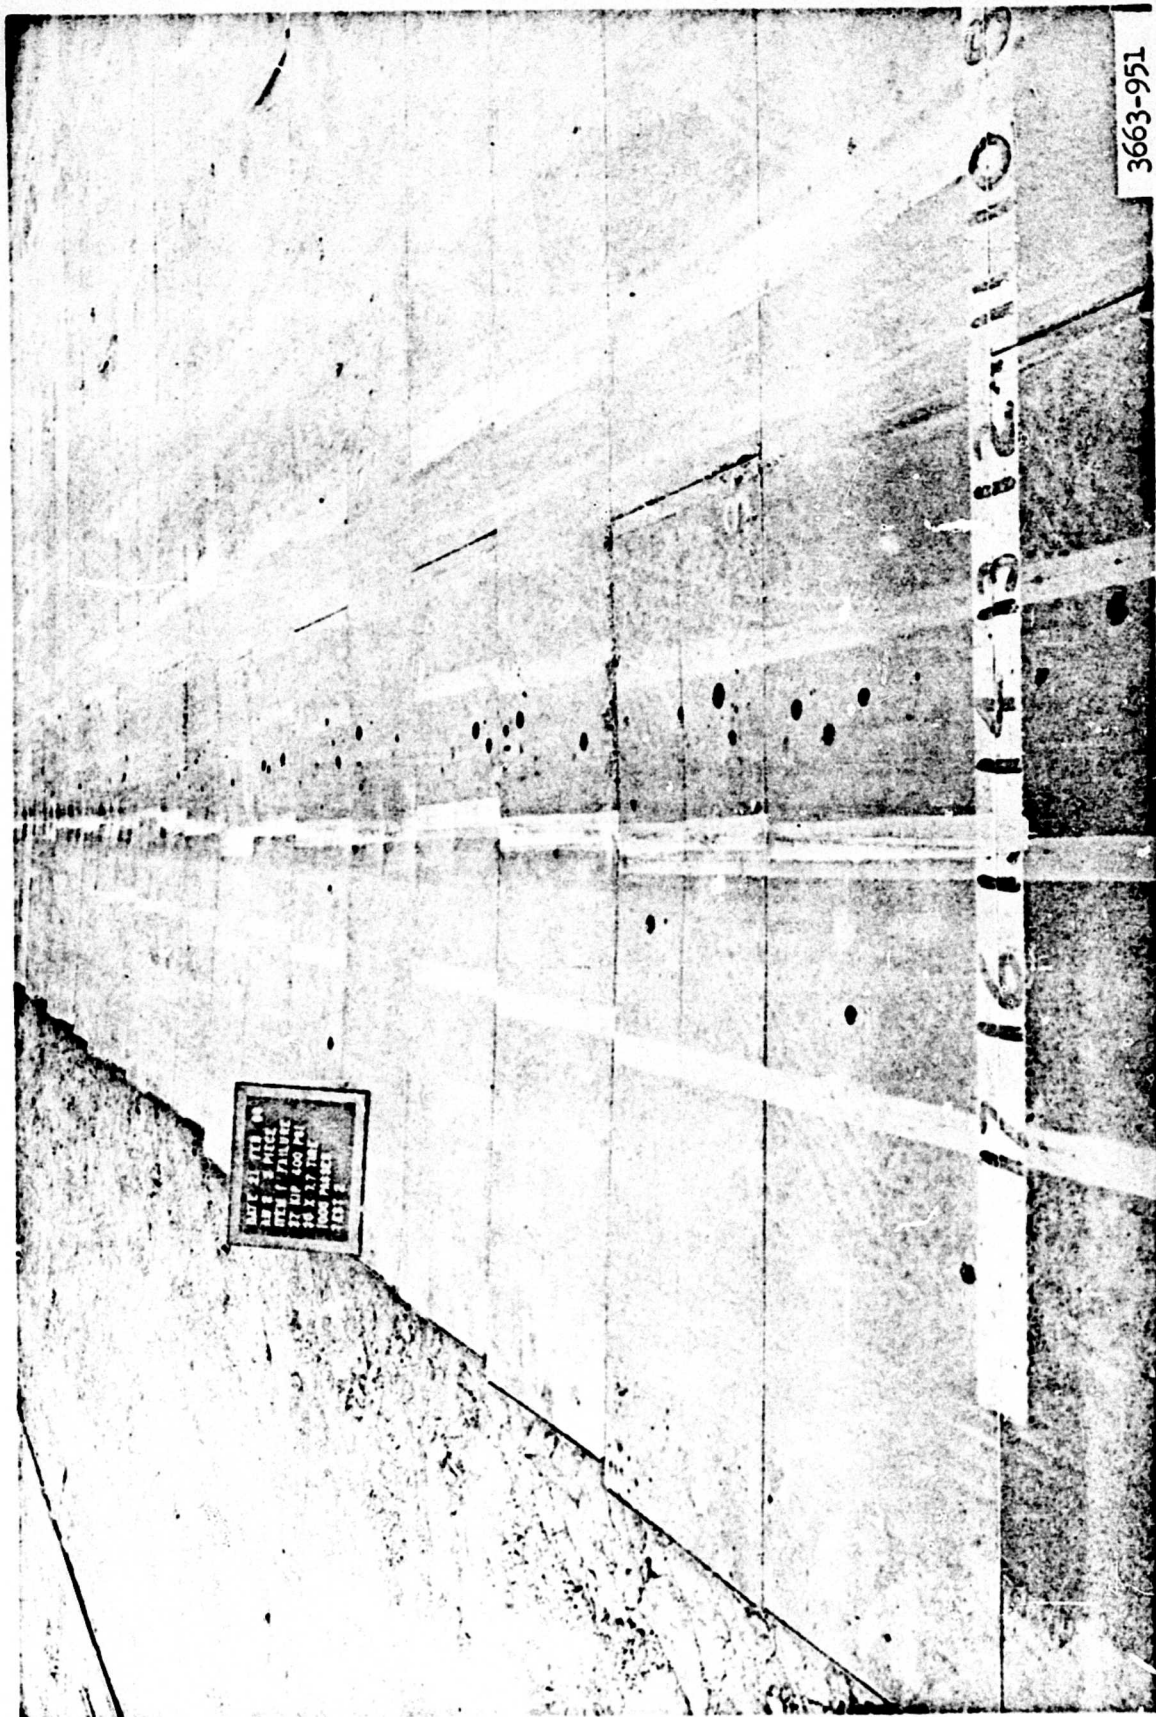
Photograph 9. Lane 2, item 1, at failure after 100 passes

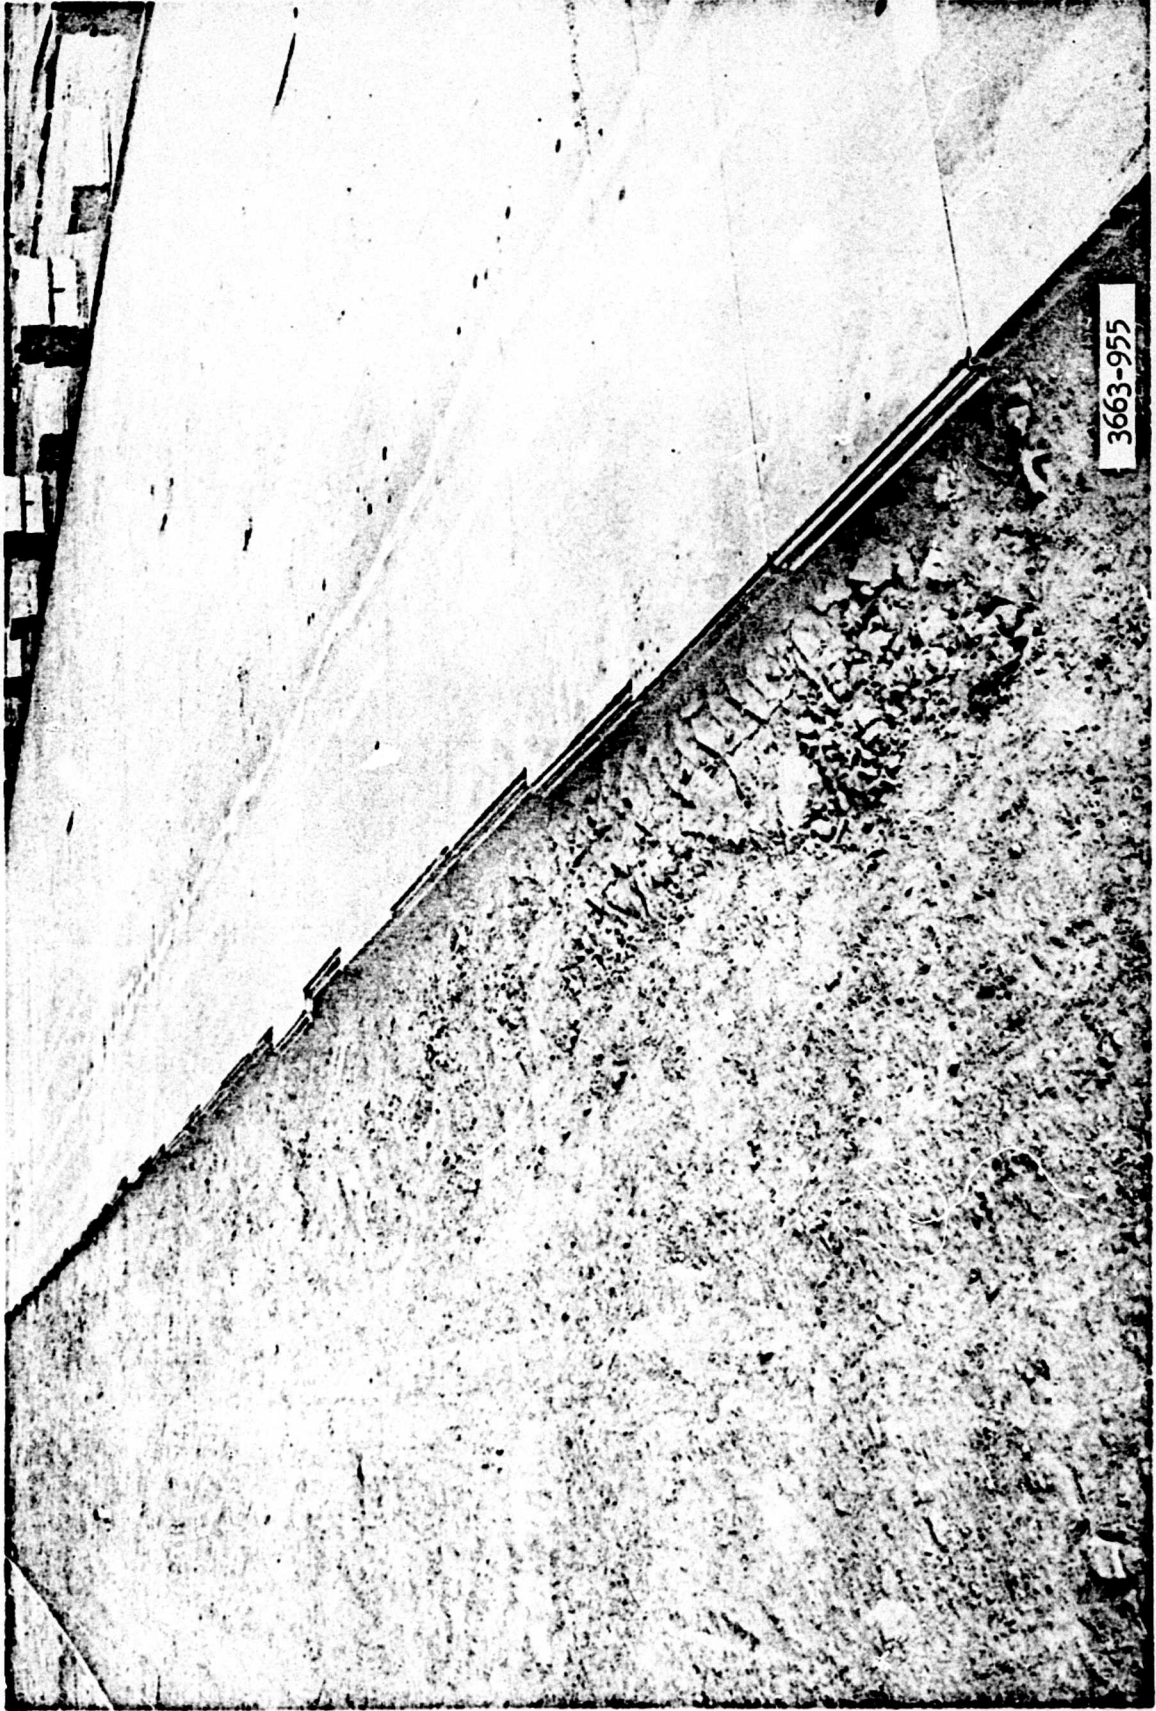
29. Visual observations. A general view of the single-line traffic lane prior to traffic is shown in photograph 7. Severe flexing of the mat on items 1 and 4 was noted from the beginning of traffic. The first mat distress noted occurred at 310 passes when the longitudinal weld of a plank in item 1 developed a crack across the width of the traffic lane. Core damage was first noted in a plank of item 1 after 600 passes. During traffic, horizontal shifting of the mat developed (photograph 8); the shifting was greatest on items 1 and 4, which required realignment at various intervals during traffic. Also visible in photograph 8 is a longitudinal weld in plank 3 which cracked after 310 passes. By 600 passes, longitudinal weld cracks had developed in three mat planks, and indications of core damage were evident in one plank. By 1000 passes, the mat surface in item 1 was very rough and core failure had developed in seven mat planks, at which time the item was considered failed. At failure, the mat surface had rutted and deformed in the traffic path (photograph 9). This deformation caused the east edge of the mat to project up approximately 3 in. off the subgrade (photograph 10).

Photograph 10. Lane 2, item 1, after 1000 passes. Note bending of mat causing edges of planks to project upwards
